BSEE PANEL REPORT 2022-002

Investigation of August 23, 2020, Pacific Khamsin Fatality

Lease OCS-G36155

Garden Banks Block 1003

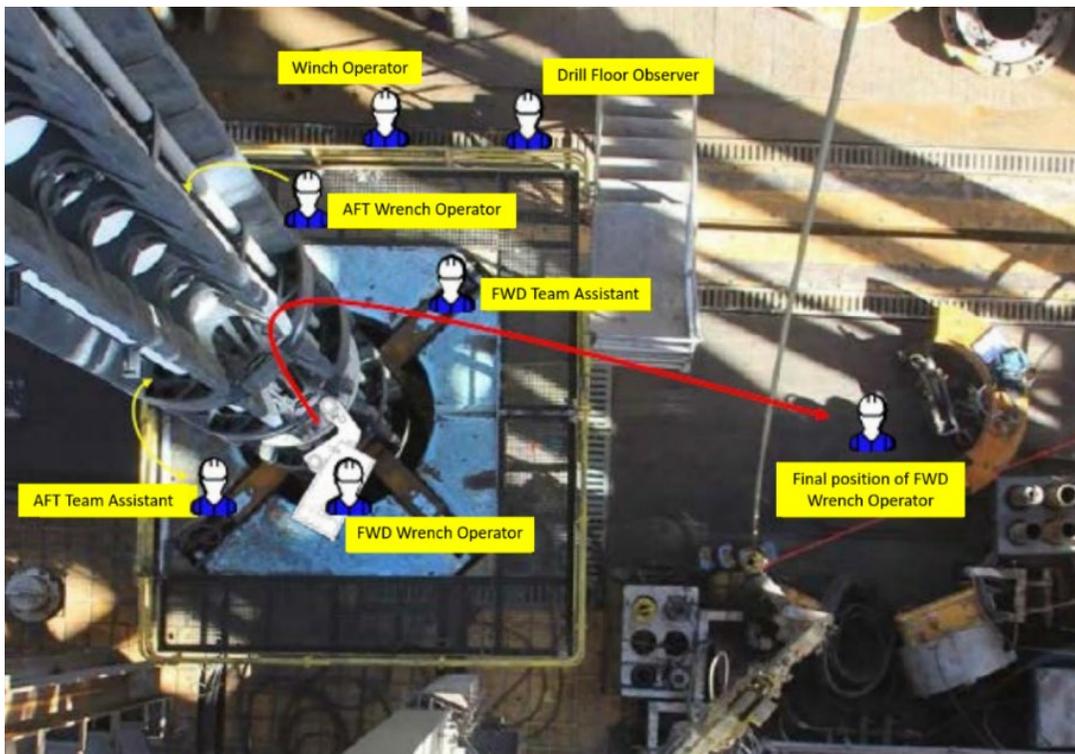
Figure 4 – Location of Personnel During Incident

After the appropriate height of the HTWs was set, both floorhand teams began to utilize the HTWs to extract the bolts from the TJ flange. As the Forward Team began to remove one of the interior bolts, the HTW socket suddenly became stuck between the bolt head and the tapered edge of the TJ. After failing to manually dislodge the HTW using physical exertion, the Forward Team flagged the HUW Operator to supply an upward force from the HUW line to free the tool. A few seconds after a pulling motion was provided from the HUW, the HTW abruptly shot vertically into the air and hit the Forward HTW Operator (i.e., the Victim). The force of the

HTW lifted the Victim into the air. The Victim struck a riser clamp approximately six feet above the elevated work deck, fell onto the handrails of the spider gimbal deck, and ultimately came to rest on the rig floor, for a total displacement of roughly 17 feet. The floorhands immediately stopped the job to render aid to the Victim as the Rear HTW Operator stayed on the spider gimbal deck to control the forward HTW which was still in motion. Once the Rig Medic arrived at the scene, the Victim was transferred onto a stretcher and moved to the drillship's hospital where the Victim became unresponsive. Despite continuous lifesaving efforts the Victim did not regain consciousness and through consultation with onshore medical personnel, the direction was given to cease resuscitation procedures. Shortly afterward, the Victim was pronounced deceased.

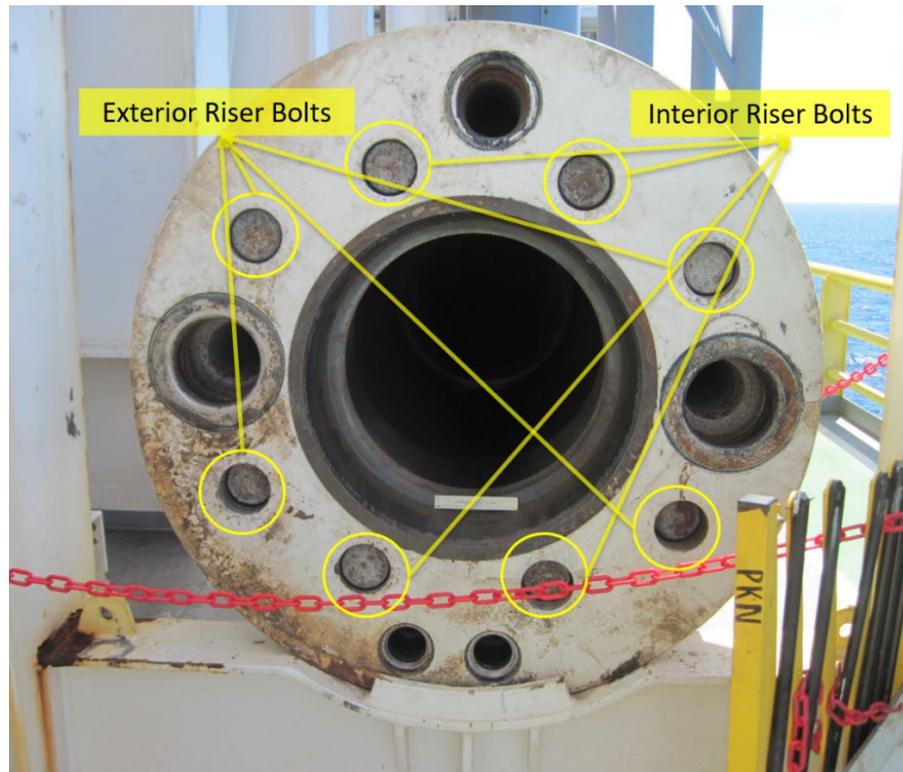
Figure 5 – Photo of Bottom of Riser Flange

Since the TJ consists of the top section of the riser, it is the first segment of the riser that reaches the rig floor when conducting the riser pull operation. After preliminary tasks were completed, such as installing the spider gimbal deck and conducting an overpull test, the TJ was set to begin the removal process. There were eight riser bolts on the flange of the TJ that needed to be extracted to successfully lay out the joint. The pattern of the eight bolts set on the TJ flange consisted of four interior bolts and four exterior bolts (Figure 5). Each of the four exterior bolts is spaced at a larger radius relative to the bolt position on the flange, creating easier access and ample space to operate the HTWs. However, due to the beveled edge design of the TJ on the lower section of the riser near the flange, each of the four interior bolts is spaced at a smaller radius relative to the bolt position on the flange. As a result, the removal of these four interior bolts required precise application of the HTWs due to the lesser surface area and smaller clearance window allowed for operation.

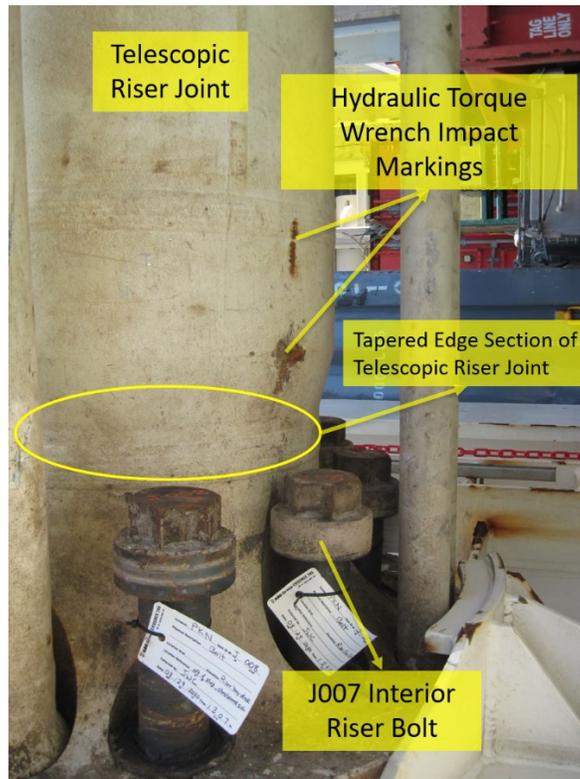
Figure 6 – Interior Riser Bolt (J007) and Telescopic Joint Involved in Incident

Photographic evidence taken by the BSEE Offshore Team noted visual abrasions on the beveled edge of the TJ directly above the J007 interior riser bolt (Figure 6) due to the rapid force released from the HTW. The Victim was working on the J007 interior riser bolt at the time of the incident. Additionally, the BSEE Offshore Team observed damage above the J010 interior riser bolt (Figure 7). The J010 interior riser bolt was not involved in the incident. The Panel was unable to determine definitively the root cause of the wear across the beveled edge above the J010 riser bolt. Multiple RFC interviewees stated that they never have witnessed the HTW getting hung up on the TJ's beveled edge during previous riser pull operations.

- Consider utilizing an HTW with a compatible design that corresponds to the beveled edge of the TJ.
- Explore options for employing a load indicator or a similar design mechanism onto the HUW package.

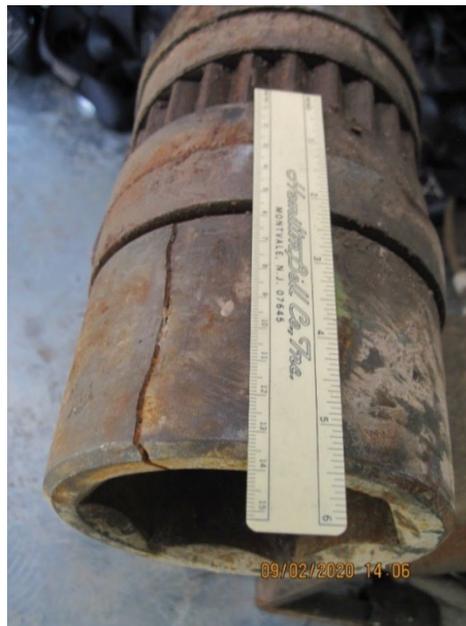
Figure 9 – Fissure Across Hydraulic Torque Wrench Socket after the Incident

The “Examination of a Hydraulic Tool Socket Failure” report analyzed the mechanical integrity of the HTW, more specifically the cause of the crack on its socket, through various engineering assessments. Stress Engineering examined the socket piece and associated bolts to determine if any indication of long-term wear was present. Stress Engineering also compared deformation

potential with a newly manufactured like-in-kind socket. The Stress Engineering report concluded that the equipment failed due to extensive tensile stress acting on the socket at the time of the incident, which resulted in the fissure extending across the socket (Figure 9).
