BSEE PANEL REPORT 2022-002

Investigation of August 23, 2020, Pacific Khamsin Fatality

Lease OCS-G36155

Garden Banks Block 1003

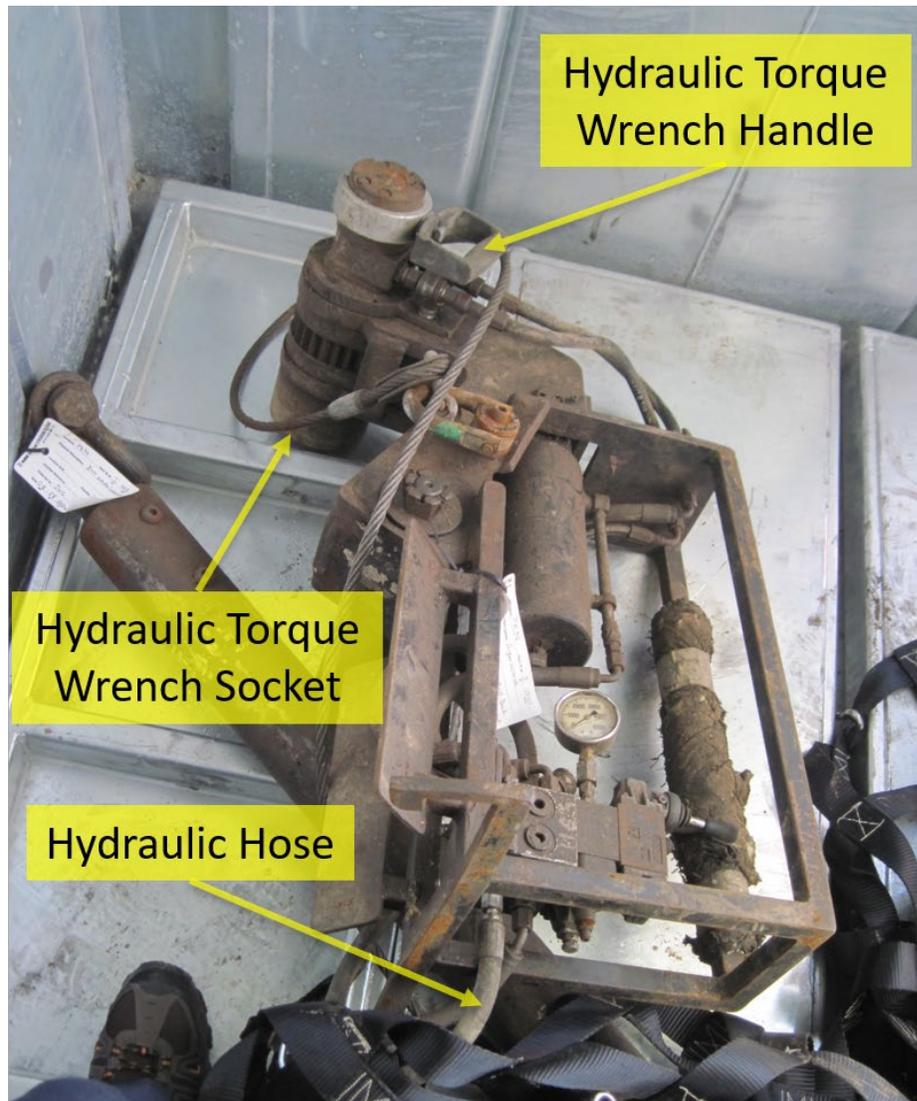
Figure 8 – Hydraulic Torque Wrench

The HTW was one of the primary pieces of equipment involved in the incident. Therefore, the Panel’s investigation concentrated on the operational aspects, as well as other characteristics of the HTW. Displayed in Figure 8 below is the HTW involved in the incident.

The “Examination of a Hydraulic Tool Socket Failure” report analyzed the mechanical integrity of the HTW, more specifically the cause of the crack on its socket, through various engineering assessments. Stress Engineering examined the socket piece and associated bolts to determine if any indication of long-term wear was present. Stress Engineering also compared deformation

potential with a newly manufactured like-in-kind socket. The Stress Engineering report concluded that the equipment failed due to extensive tensile stress acting on the socket at the time of the incident, which resulted in the fissure extending across the socket (Figure 9).

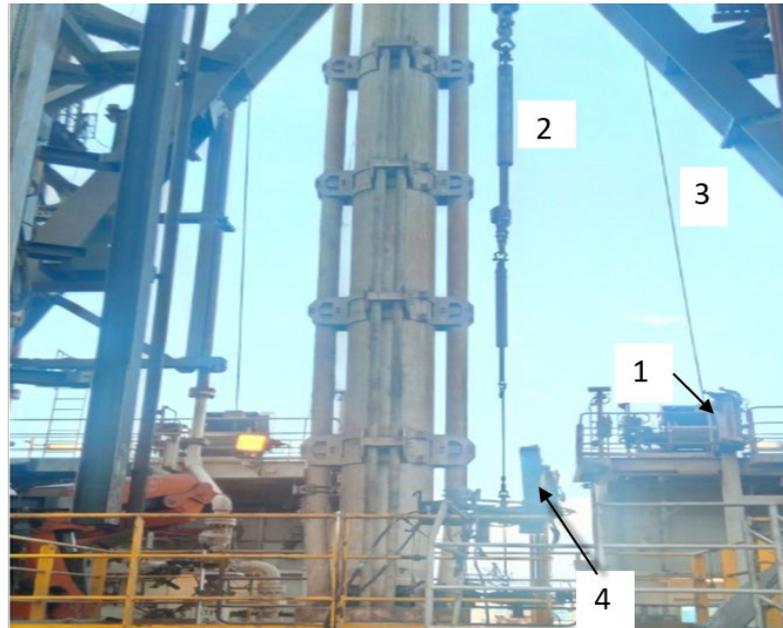
The HUW is the key supplemental equipment involved in the incident. As mentioned in the HTW section previously, the HUW connects the HTW support cable through a spring-loaded balancer known as the zero-gravity compensator to support the significant weight of the HTW on the rig floor. The HUW assembly is shown in Figure 10. The HUW was the actual mechanism used for vertically hoisting the HTW to the proper operational height via the use of the HUW electronic remote controller.

The Panel primarily reviewed the Pacific Maintenance Records for the HUW and its associated components to understand its operational abilities as well as to understand its impacts on the incident. The maintenance logs indicate that certain HUW parts are required to be inspected at established intervals to identify any deficiencies with the equipment. The results from the 1-year and 5-year inspection intervals were provided to the Panel by TEPUSA. The Panel noted that the inspection included an evaluation of the overall condition of the HUW, along with verification that parts such as the wire rope, drum, filters, valves, fittings, etc., did not exhibit any fatigue, wear, or damage. The Panel noted that neither inspection identified deficiencies associated with the HUW. Therefore, no corrective maintenance work orders were required to be initiated.
